**Flood Control Project Maintenance
Levee Inspections**

Fall 2011 Levee Maintenance Deficiency Summary Report

San Joaquin River Basin

Reclamation District No. 2089 Stark

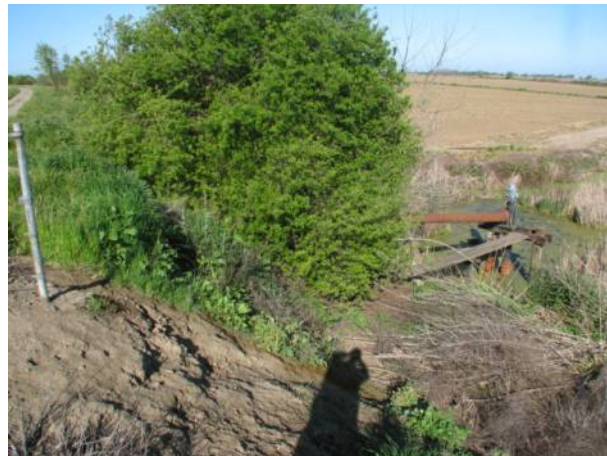
Levee Mile Report Line	3
Start Levee Mile	0.04
End Levee Mile	0.04
Location	Land Side
Category	Earthen Levee
Item	Trim / Thin Trees
Trees on landside slope limit access and visibility.	
jeto_f_20110923_227.jpg

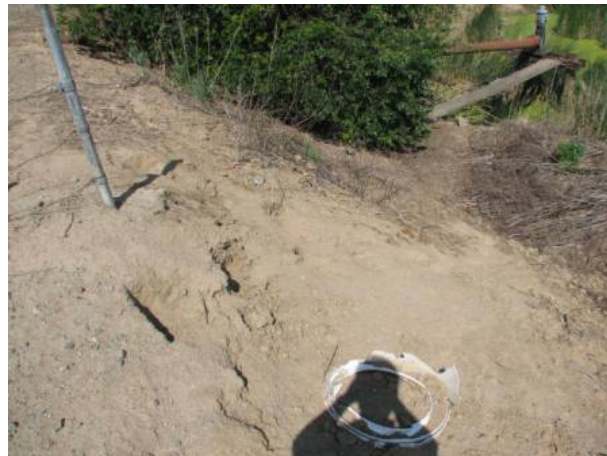
Levee Mile Report Line	5
Start Levee Mile	0.04
End Levee Mile	0.04
Location	Land Side
Category	Earthen Levee
Item	Encroachments
05/24/2011 Steps are hard to discern in the photo, the top two steps are casting the two shadows located between the post and the photographer's shadow.	
jeto_f_20110923_225.jpg

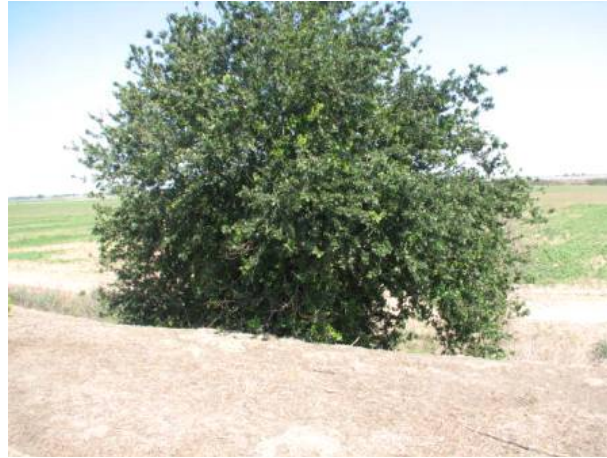
Levee Mile Report Line	6
Start Levee Mile	0.10
End Levee Mile	0.10
Location	Land Side
Category	Earthen Levee
Item	Trim / Thin Trees
05/24/2011 Issue remains unchanged since noted in the Fall 2010 inspection.	
jeto_f_20110923_258.jpg

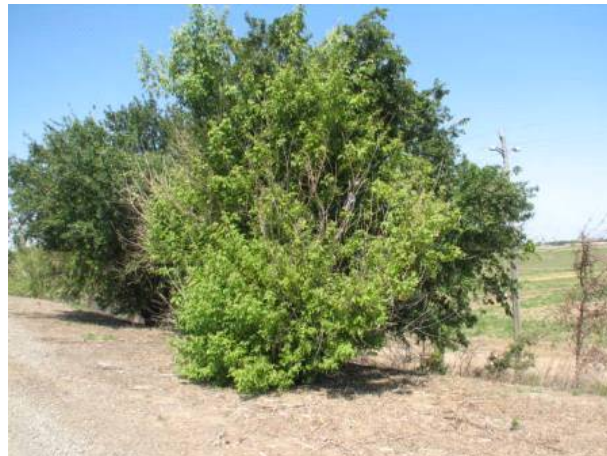
Levee Mile Report Line	9
Start Levee Mile	0.23
End Levee Mile	0.23
Location	Land Side
Category	Earthen Levee
Item	Trim / Thin Trees
05/24/2011 Tree was also noted in the Fall 20110 inspection.	
jeto_f_20110923_259.jpg

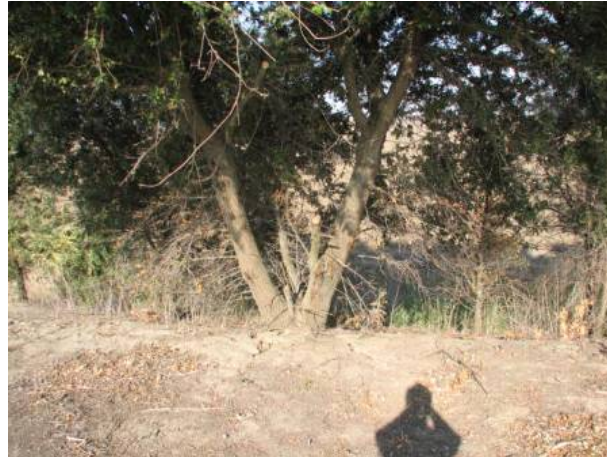
Levee Mile Report Line	9
Start Levee Mile	0.23
End Levee Mile	0.23
Location	Land Side
Category	Earthen Levee
Item	Trim / Thin Trees

11/10/2011 Tree has been limbed up, but still needs to be cleared around the bottom to permit access to the slope in the event of a flood fight.

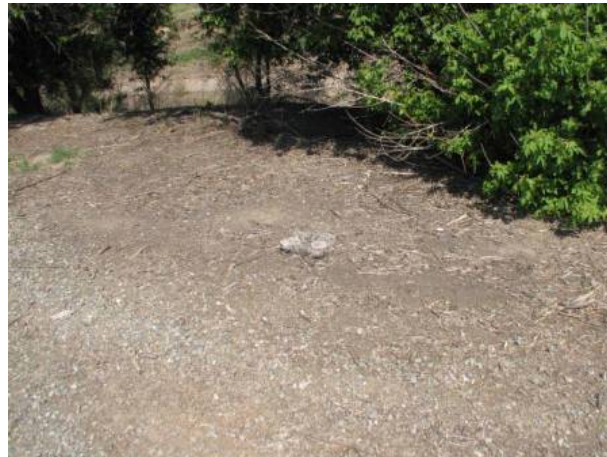
Levee Mile Report Line	10
Start Levee Mile	0.24
End Levee Mile	0.24
Location	Land Side
Category	Earthen Levee
Item	Trim / Thin Trees

05/24/2011 Stump shown in center of photo.

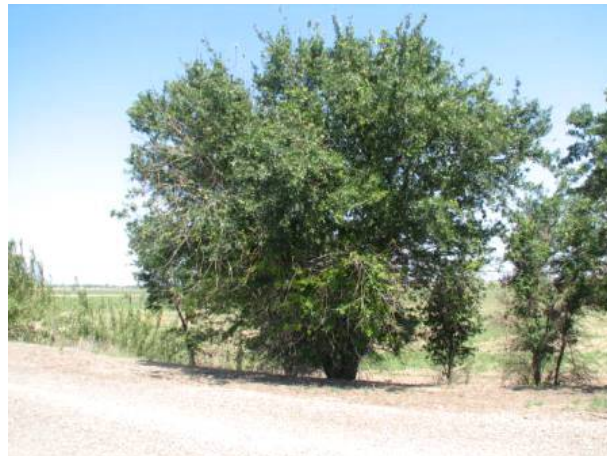
Levee Mile Report Line	11
Start Levee Mile	0.24
End Levee Mile	0.24
Location	Water Side
Category	Earthen Levee
Item	Trim / Thin Trees

05/24/2011 Tree must be trimmed up 5'. Issue noted in Fall 2010 inspection.

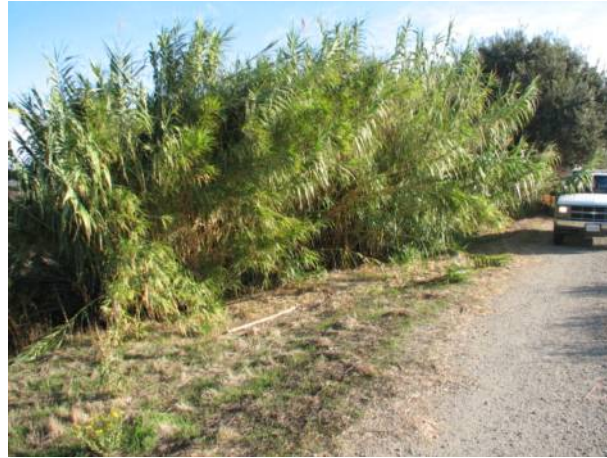
Levee Mile Report Line	12
Start Levee Mile	0.24
End Levee Mile	0.24
Location	Land Side
Category	Earthen Levee
Item	Vegetation

Bamboo on levee slope and crown obstruct access and visibility.

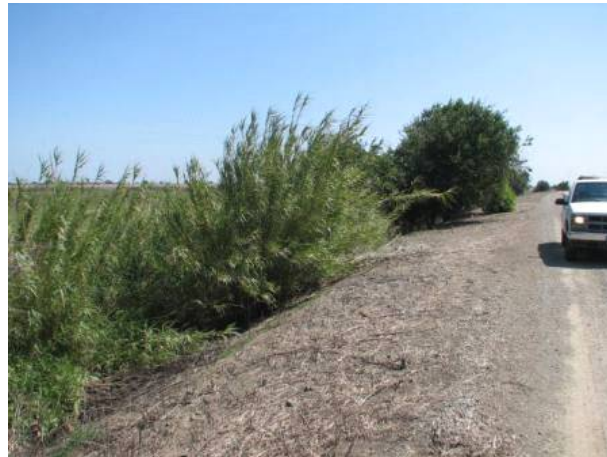
Levee Mile Report Line	12
Start Levee Mile	0.24
End Levee Mile	0.24
Location	Land Side
Category	Earthen Levee
Item	Vegetation

05/24/2011 Bamboo has been trimmed back off of crown, but still completely blocks access and visibility.

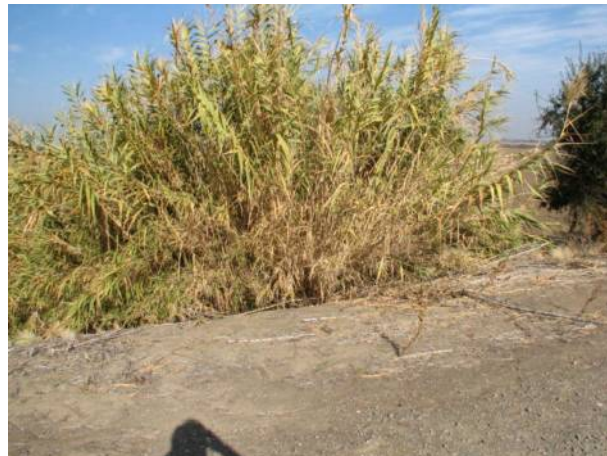
Levee Mile Report Line	12
Start Levee Mile	0.24
End Levee Mile	0.24
Location	Land Side
Category	Earthen Levee
Item	Vegetation

11/10/2011 Arundo has been trimmed back, but vegetation on the landside slope must be cleared to 15' beyond the toe.

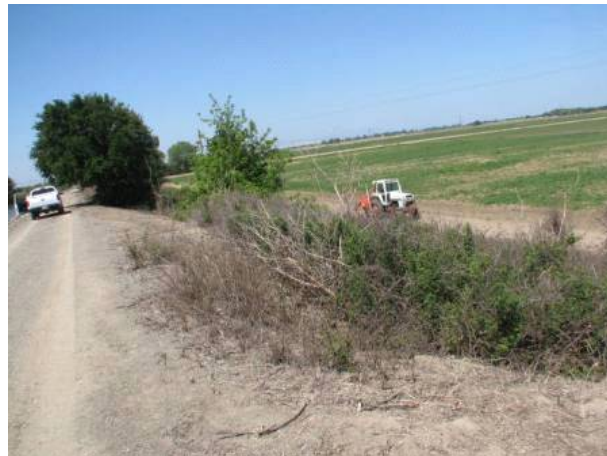
Levee Mile Report Line	16
Start Levee Mile	0.27
End Levee Mile	0.39
Location	Land Side
Category	Earthen Levee
Item	Vegetation
05/24/2011 Thick brush and wild rose completely block access and visibility of landside slope and toe.	
jeto_f_20110923_238.jpg

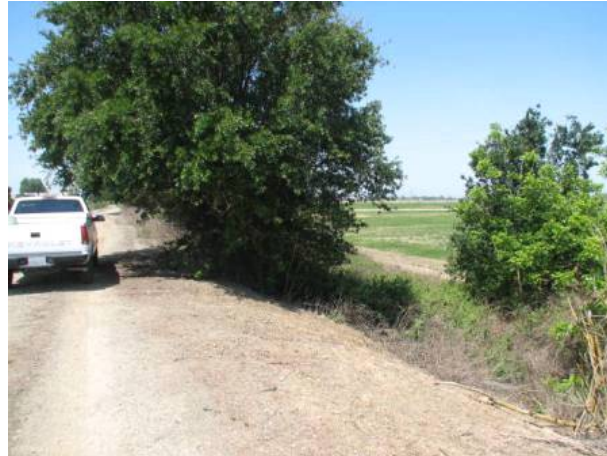
Levee Mile Report Line	17
Start Levee Mile	0.29
End Levee Mile	0.34
Location	Land Side
Category	Earthen Levee
Item	Trim / Thin Trees
05/24/2011 Numerous trees and thick vegetation in area, trees need to be trimmed to 12' above roadway and up 5' on landside slope and toe to allow access and visibility.	
jeto_f_20110923_242.jpg

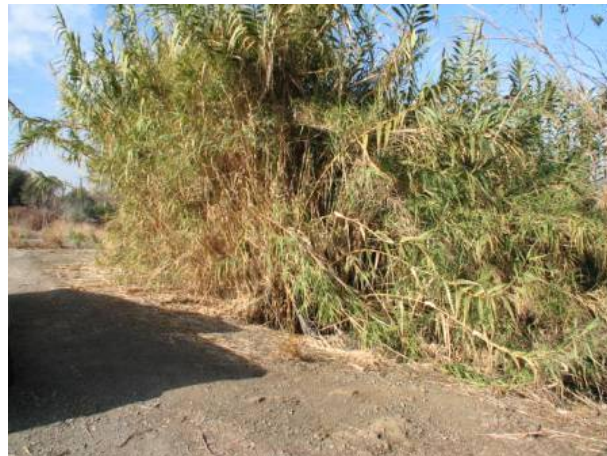
19	0.34	0.34	Earthen Levee	Vegetation	LS	U	Remove the wild growth other than native grasses from the levee slopes. Inspector Comments: Bamboo completely blocks access and visibility.11/10/2011 Arundo has been trimmed back from the roadway, but still completely blocks access and visibility to the landside slope. This plant was improperly identified as bamboo in previous inspections.	37.809978 ° -121.390704 °	37.809978 ° -121.390704 °	19 Y
20	0.38	0.38	Earthen Levee	Trim / Thin Trees	LS	U	Trim trees to at least five feet above ground level.	37.809865 ° -121.391303 °	37.809865 ° -121.391303 °	946 Y
21	0.39	0.39	Earthen Levee	Trim / Thin Trees	LS	M	Thin trees to allow visibility of the ground and room to flood fight.	37.809788 ° -121.391490 °	37.809788 ° -121.391490 °	26 Y
22	0.41	0.41	Supplemental	DWR Erosion Survey	WS	W	Inspector Comments: 08/23/2011: Boat survey uncovered a 10-ft vertical scarp just upstream of the revetment. Vegetation and trees on site. 09/07/2010: Site appears to have been repaired by placing shot rock as rip rap protection. Note patches of seasonal grass on revetment. It is recommended that an inspection in the near future be conducted to verify the condition of the revetment. Site was previously rated "M".08/06/2010: Recommended as local maintenance issue, per CLRO.09/28/2009: Rock protection was recently placed along the upper slope; photographs need to be updated; site is recommended for annual assessment and monitoring of erosion site, per CLRO CES Evaluation 2008 Report; Site # is the same as RM29.84,LM0.30; previously rated "M".11/05/2008: Two sites have been combined as one supersite; steep ws slope and downstream of a pump.10/20/2006: Visited site 10/20/2006. [2011 Site ID:RD2089U01RM29.83]	37.809530 ° -121.392160 °	37.809530 ° -121.392160 °	52 Y

Levee Mile Report Line	19
Start Levee Mile	0.34
End Levee Mile	0.34
Location	Land Side
Category	Earthen Levee
Item	Vegetation
11/10/2011 Arundo has been trimmed back from the road, but needs to be removed to so that it does not obstruct visibility and access to the landside slope.	
jeto_f_20111121_603.jpg

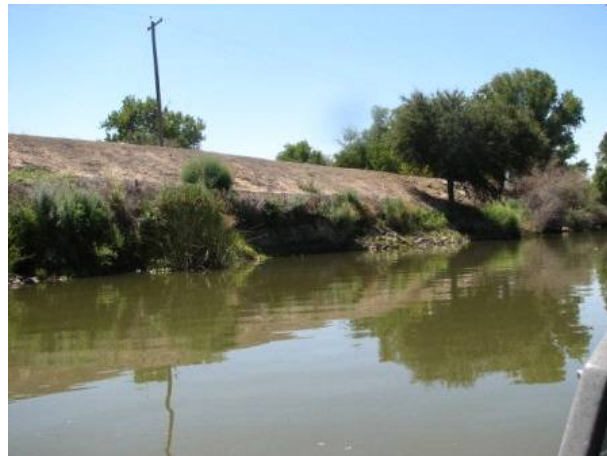
Levee Mile Report Line	22
Start Levee Mile	0.41
End Levee Mile	0.41
Location	Water Side
Category	Supplemental
Item	DWR Erosion Survey
Upstream view of the scarp at the levee toe	
SJR2011_RD2089U01RM29.83_1.jpg

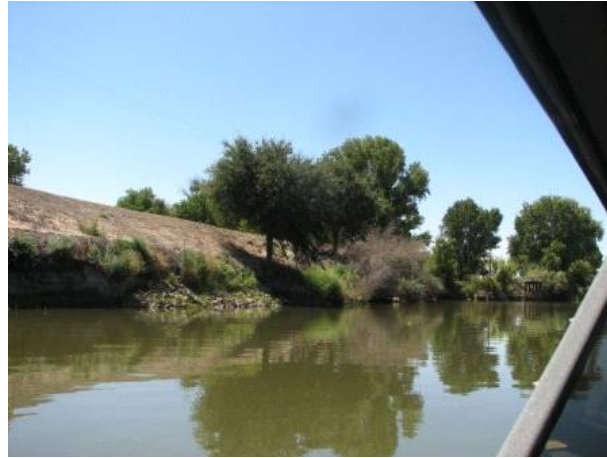
upstream view of the scarp.

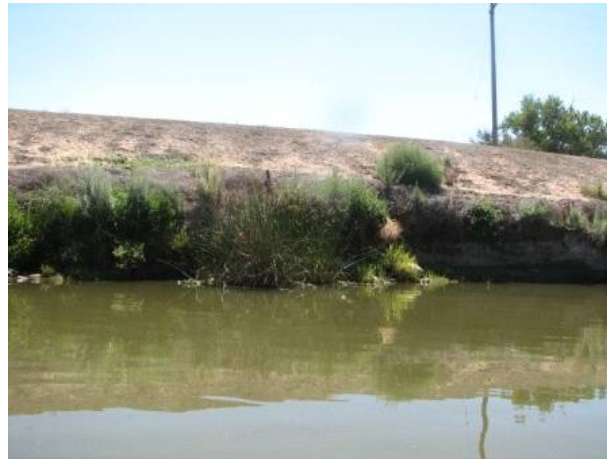
Levee Mile Report Line	22
Start Levee Mile	0.41
End Levee Mile	0.41
Location	Water Side
Category	Supplemental
Item	DWR Erosion Survey

Front view of the repaired site.

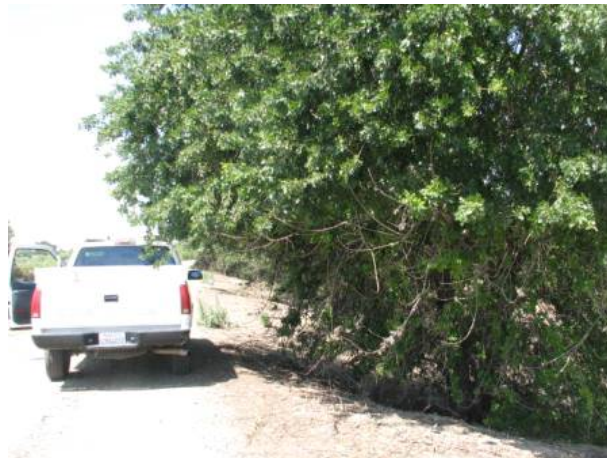
Levee Mile Report Line	23
Start Levee Mile	0.42
End Levee Mile	0.48
Location	Land Side
Category	Earthen Levee
Item	Trim / Thin Trees

05/24/2011 Trees need to be trimmed to 12' over roadway and up 5' on levee slope to allow access and visibility.

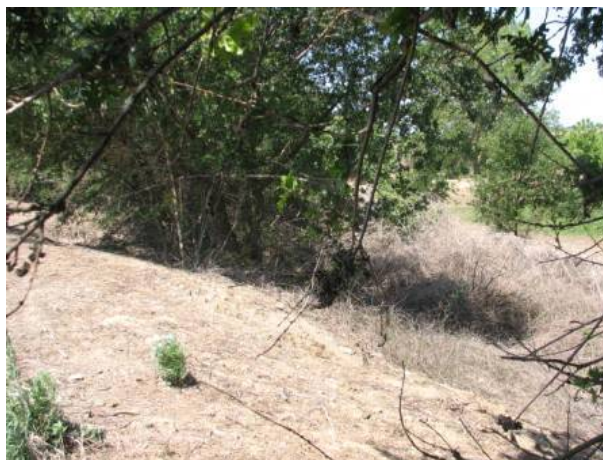
05/24/2011 Photo shows thick dead vegetation and continuation of trees in area that are preventing access and visibility of landside slope and toe.

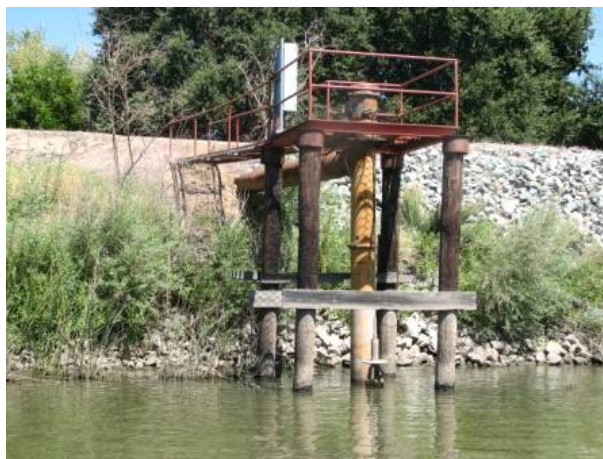
Levee Mile Report Line	25
Start Levee Mile	0.45
End Levee Mile	0.45
Location	Water Side
Category	Supplemental
Item	DWR Erosion Survey

Front view of the site. Note the color of material around the pipe crossing.

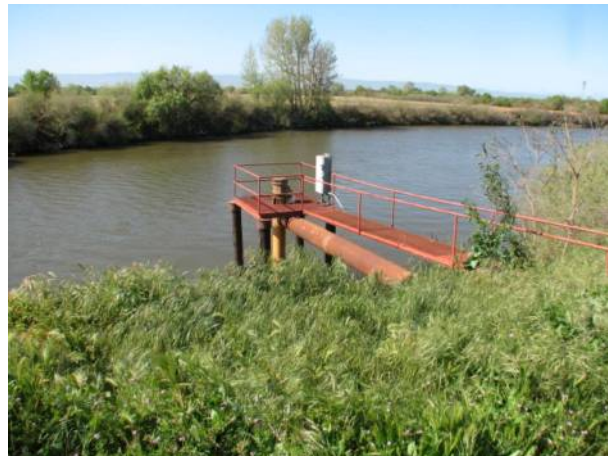
Levee Mile Report Line	26
Start Levee Mile	0.47
End Levee Mile	0.47
Location	Water Side
Category	Earthen Levee
Item	Encroachments

Irrigation intake pump and pipe at LM 0.46.

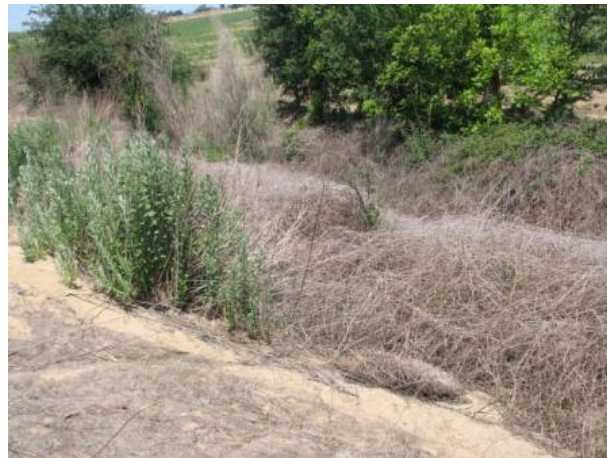
Levee Mile Report Line	28
Start Levee Mile	0.50
End Levee Mile	0.50
Location	Land Side
Category	Earthen Levee
Item	Vegetation
05/24/2011 Dead brush is too thick to allow access and visibility of landside slope and toe.	
jeto_f_20110923_250.jpg

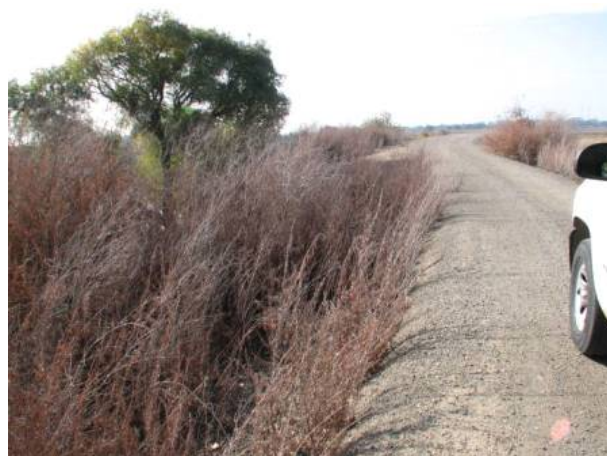
Levee Mile Report Line	31
Start Levee Mile	0.64
End Levee Mile	1.53
Location	Water Side
Category	Earthen Levee
Item	Vegetation
11/10/2011 Vegetation needs to be cleared on the upper 20' of the waterside slope.	
jeto_f_20111121_607.jpg

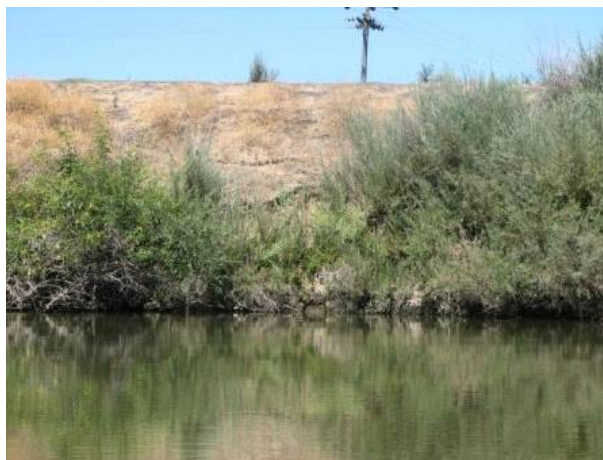
LMR No.	Levee Mile		Category	Item	Location	Rating	Action/Comment	GPS Latitude/Longitude		Issue No.
	Start	End						Start	End	
33	0.66	0.66	Supplemental	DWR Erosion Survey	WS	U	Inspector Comments: 08/23/2011: The 5-foot vertical scarp shows no significant change from the last year inspection. No new erosion activities observed. Dense white willow trees on site. 09/07/2010: It was difficult to view the erosion due to the thick Willow thickets and other vegetation at the water line. At the time of the inspection, there were no signs of repair on site. As noted during the last survey, there is a 5-foot vertical scarp along the lower slope that may be subjected to high flow velocities. 08/05/2010: Recommended for repair, per CLRO; "Erosion of this site may be subjective to rapid rates of erosion." 09/28/2009: No major change observed; 5-foot vertical scarp is immediately downstream of where berm has tapered; site is recommended as local maintenance issue, per CLRO CES Evaluation 2008 Report; Site # is the same as RM29.6, LM0.60; previously rated "U". 11/05/2008: No change observed; rodent holes on lower slope; wide levee crown. [2011 Site ID: RD2089U01RM29.61]	37.809780 ° -121.396230 °	37.809780 ° -121.396230 °	50 Y

Front view of the site. The scarp is visible on the slope.

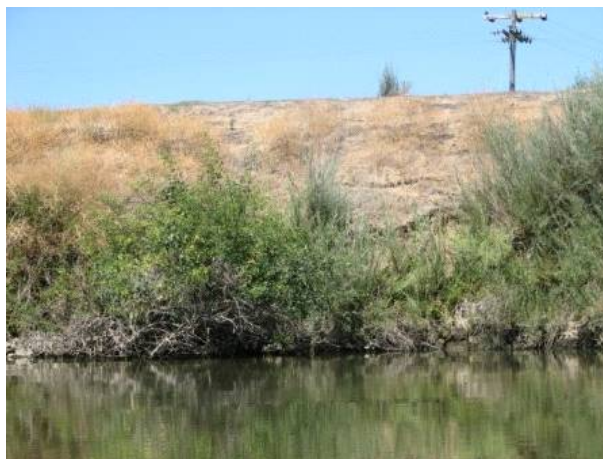
Levee Mile Report Line	33
Start Levee Mile	0.66
End Levee Mile	0.66
Location	Water Side
Category	Supplemental
Item	DWR Erosion Survey

Downstream view of the site. Note the very dense white willow thickets on site.

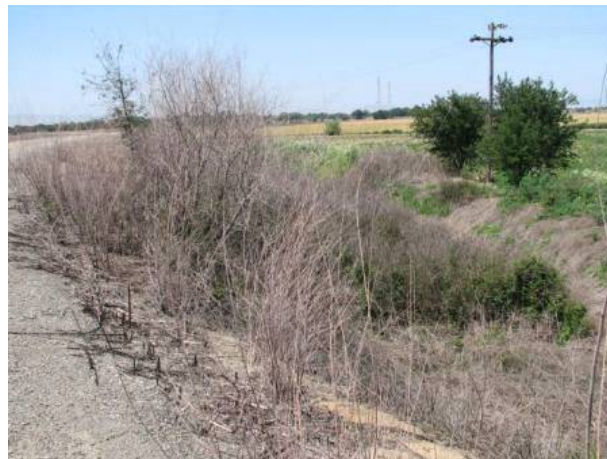
Levee Mile Report Line	34
Start Levee Mile	0.67
End Levee Mile	0.68
Location	Land Side
Category	Earthen Levee
Item	Vegetation

05/24/2011 Vegetation is mostly dead but needs to be removed to allow access and visibility of slope and toe.

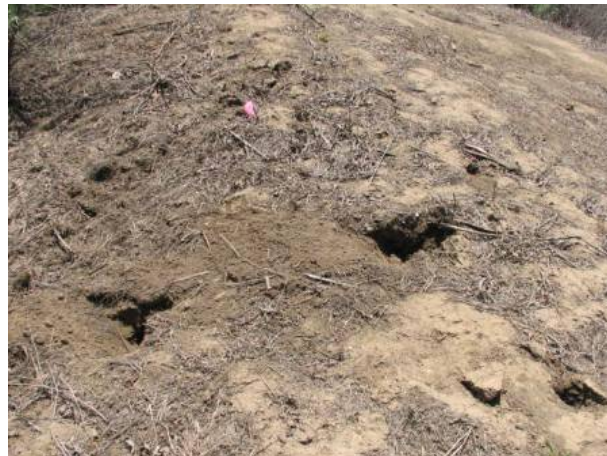
Levee Mile Report Line	35
Start Levee Mile	0.67
End Levee Mile	0.67
Location	Water Side
Category	Earthen Levee
Item	Animal Control

05/24/2011 Two active burrows shown in photo.

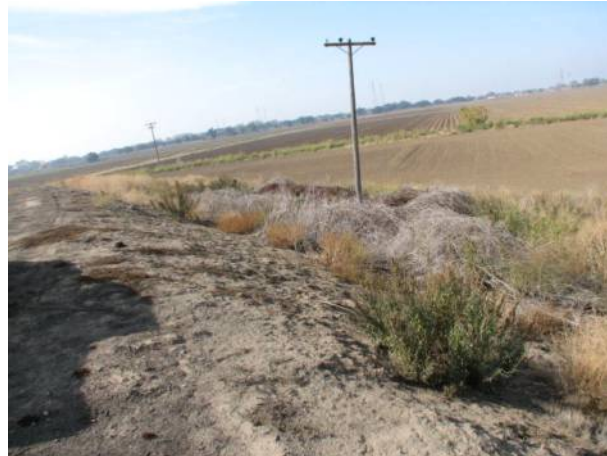
Levee Mile Report Line	36
Start Levee Mile	0.73
End Levee Mile	0.77
Location	Land Side
Category	Earthen Levee
Item	Vegetation
11/10/2011 Vegetation obstructs visibility of slope and toe.	
jeto_f_20111121_608.jpg

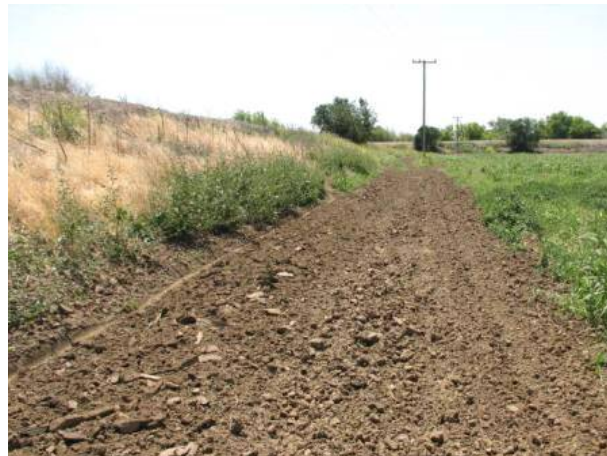
Levee Mile Report Line	39
Start Levee Mile	0.85
End Levee Mile	0.85
Location	Land Side
Category	Earthen Levee
Item	Encroachments
05/24/2011 Photo shows tilling issue noted in Fall 2010 inspection has been corrected, tilling now stops at toe of landside slope.	
jeto_f_20110923_253.jpg

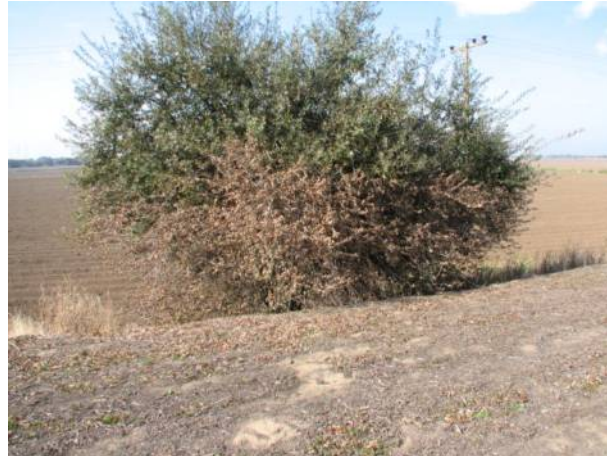
Levee Mile Report Line	40
Start Levee Mile	0.88
End Levee Mile	0.88
Location	Land Side
Category	Earthen Levee
Item	Trim / Thin Trees
11/10/2011 Tree appears to have been sprayed, needs to be limbed up 5' to allow for visibility of slope and toe.	
jeto_f_20111121_609.jpg

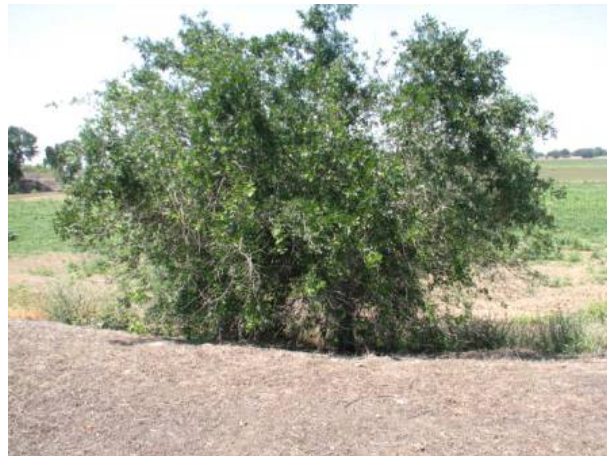
Levee Mile Report Line	42
Start Levee Mile	0.97
End Levee Mile	0.97
Location	Land Side
Category	Earthen Levee
Item	Trim / Thin Trees
05/24/2011 Tree needs to be trimmed up 5'.	
jeto_f_20110923_254.jpg

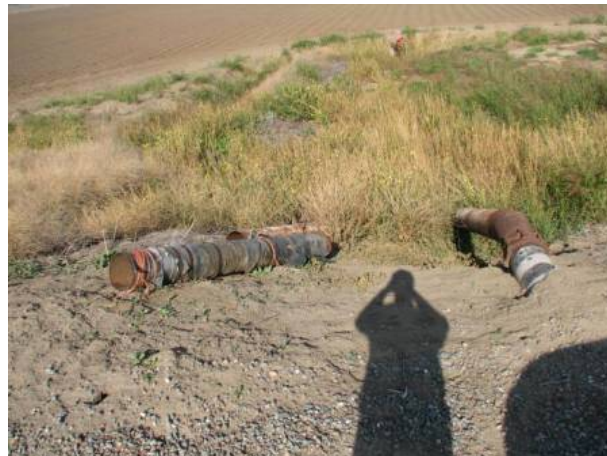
Levee Mile Report Line	50
Start Levee Mile	1.16
End Levee Mile	1.16
Location	Land Side
Category	Earthen Levee
Item	Encroachments
11/10/2011 Section of ductilie iron pipe that speears to be left from a pipe repair. Needs to be removed.	
jeto_f_20111121_613.jpg

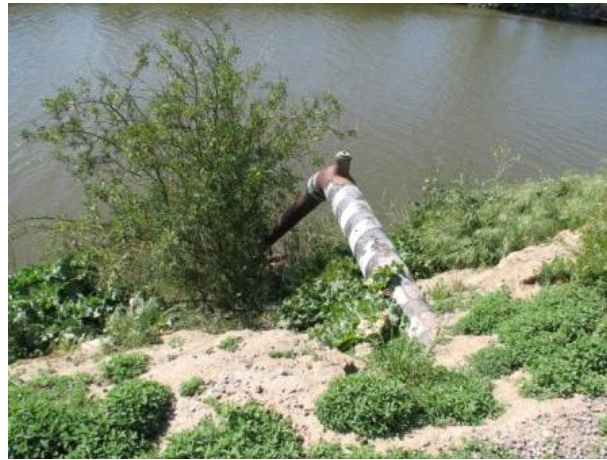
Drainage discharge into Old River.

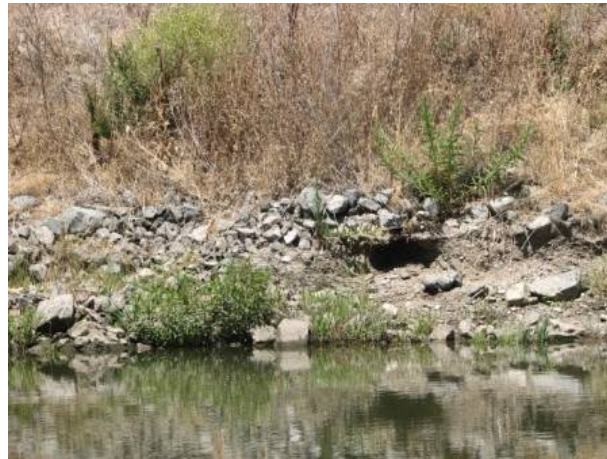
Levee Mile Report Line	52
Start Levee Mile	1.18
End Levee Mile	1.18
Location	Water Side
Category	Supplemental
Item	DWR Erosion Survey

LMR No.	Levee Mile		Category	Item	Location	Rating	Action/Comment	GPS Latitude/Longitude		Issue No.
	Start	End						Start	End	
52	1.18	1.18	Supplemental	DWR Erosion Survey	WS	W	Inspector Comments: 08/23/2011: Minor erosion activities are observed at the toe of the rip rap. Dense vegetation can block view for potential erosion. 09/07/2010: Site has been repaired. It appears that additional shot rock was placed on top of the exposed area, adding protection at the levee toe. Site was previously rated "M". 08/06/2010: Recommended as local maintenance issue, per CLRO.2009: Existing revetment just above the toe is sloughing; site is recommended for local maintenance issue, per CLRO CES Evaluation 2008 Report; Site # is the same as RM29.10, LM1.10; previously rated "M". 10/20/2006: Toe slough; existing revetment. [2011 Site ID:RD2089U01RM29.11]	37.805530 ° -121.401700 °	37.805530 ° -121.401700 °	4 Y

A close view of the minor erosion activities.

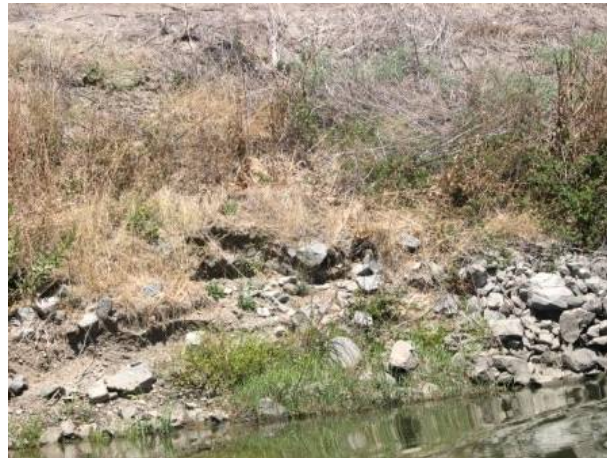
Close view of the minor erosion activities.

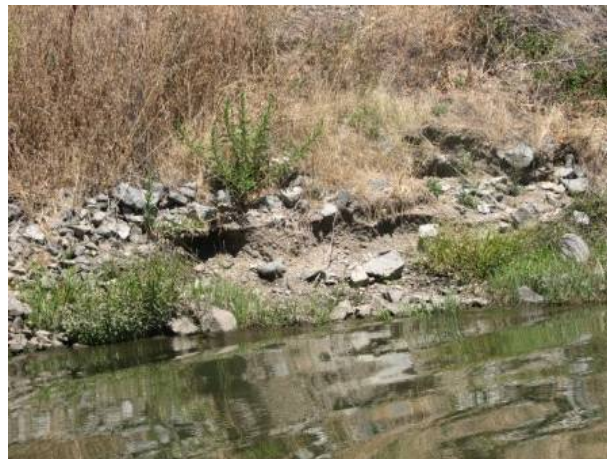
SJR2011_RD2089U01RM29.11_4.jpg

Close view of the minor erosion activities.

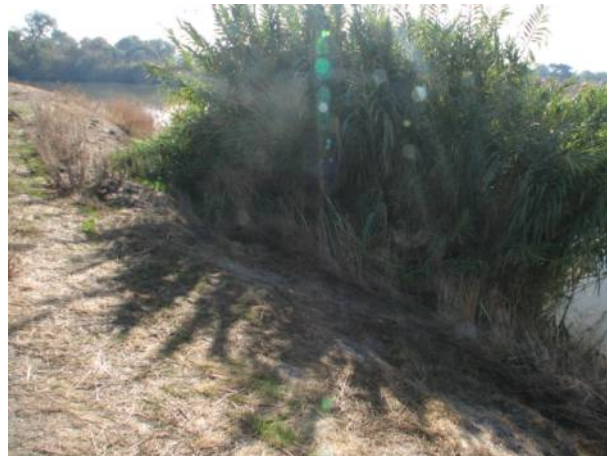
jeto_f_20110923_245.jpg

Levee Mile Report Line	53
Start Levee Mile	1.22
End Levee Mile	1.22
Location	Water Side
Category	Earthen Levee
Item	Vegetation

Bamboo on waterside levee slope obstructs access and visibility.

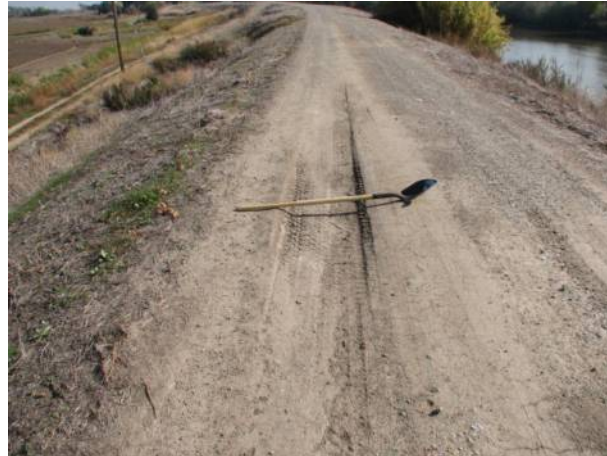
Levee Mile Report Line	54
Start Levee Mile	1.25
End Levee Mile	1.25
Location	Crown
Category	Earthen Levee
Item	Crown Surface / Depressions / Rutting
11/10/2011 Depression in roadway.	
jeto_f_20111121_614.jpg

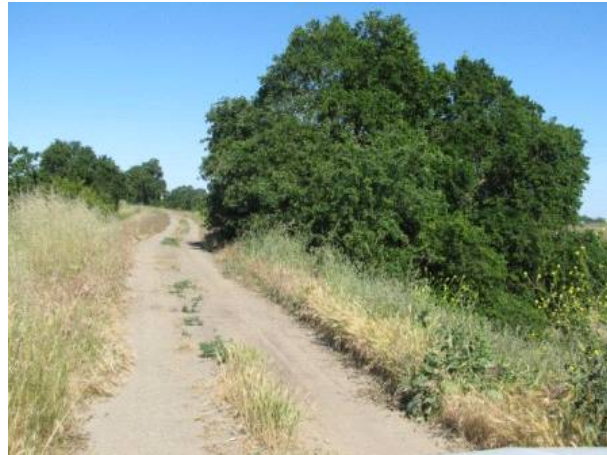
Levee Mile Report Line	55
Start Levee Mile	1.26
End Levee Mile	1.26
Location	Land Side
Category	Earthen Levee
Item	Trim / Thin Trees
Trees on levee slope obstruct access and visibility.	
jeto_f_20110923_240.jpg

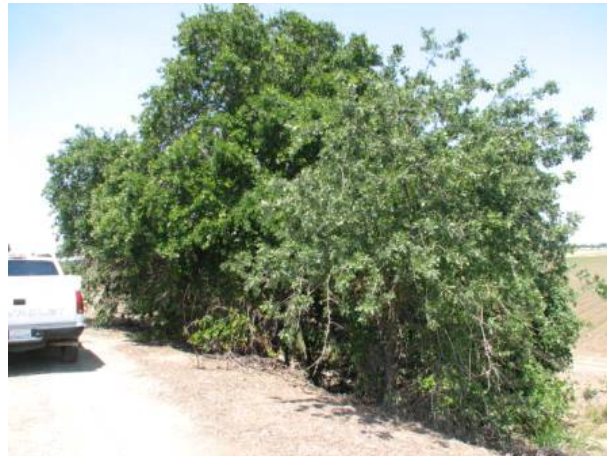
Levee Mile Report Line	55
Start Levee Mile	1.26
End Levee Mile	1.26
Location	Land Side
Category	Earthen Levee
Item	Trim / Thin Trees
05/24/2011 Trees have been trimmed since Fall 2010 inspection, however they still need to be trimmed up 5' to allow visibility of slope and access in a flood fight.	
jeto_f_20110923_241.jpg

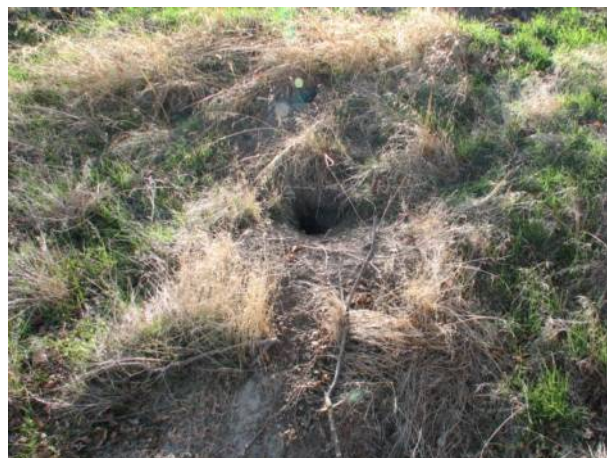
Levee Mile Report Line	58
Start Levee Mile	1.43
End Levee Mile	1.43
Location	Land Side
Category	Earthen Levee
Item	Animal Control
11/10/2011 Active rodent burrow on landside slope.	
jeto_f_20111121_618.jpg

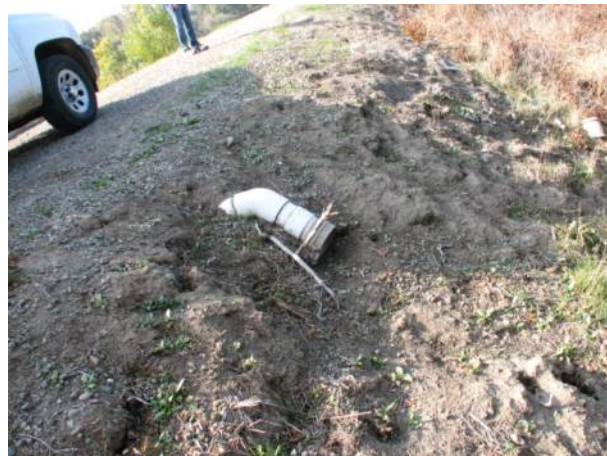
Levee Mile Report Line	60
Start Levee Mile	1.45
End Levee Mile	1.45
Location	Crown
Category	Earthen Levee
Item	Encroachments
11/10/2011 PVC pipe on landside slope. Pipe needs to be removed.	
jeto_f_20111121_620.jpg

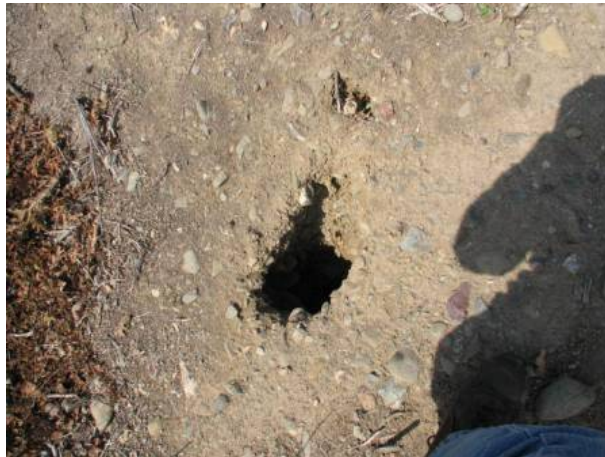
Levee Mile Report Line	62
Start Levee Mile	1.47
End Levee Mile	1.47
Location	Water Side
Category	Earthen Levee
Item	Animal Control
11/10/2011 Deep burrow on waterside.	
jeto_f_20111121_621.jpg

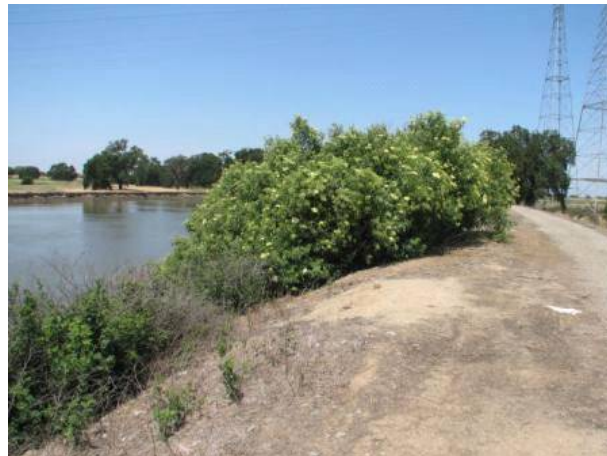
Levee Mile Report Line	3
Start Levee Mile	0.08
End Levee Mile	0.08
Location	Water Side
Category	Earthen Levee
Item	Vegetation
05/24/2011 Updated photo of issue noted in Fall 2010 inspection.	
jeto_f_20110923_271.jpg

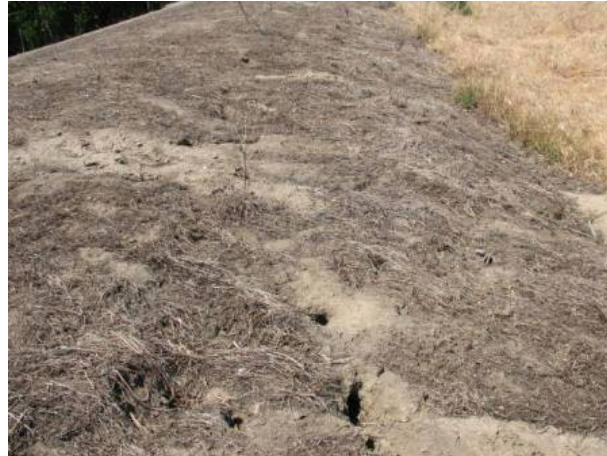
Levee Mile Report Line	6
Start Levee Mile	0.28
End Levee Mile	0.28
Location	Land Side
Category	Earthen Levee
Item	Animal Control
05/24/2011 Active burrows, ground squirrel sighted in area.	
jeto_f_20110923_279.jpg

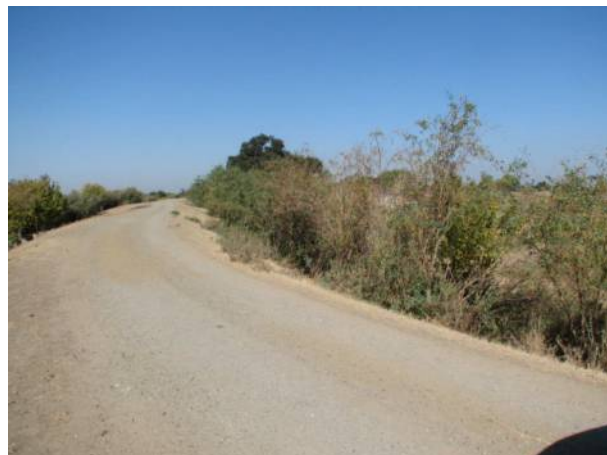
Levee Mile Report Line	10
Start Levee Mile	0.40
End Levee Mile	0.66
Location	Land Side
Category	Earthen Levee
Item	Vegetation
Fall 2009 photo: brush on landside toe limits visibility and accessibility.	
jeto_f_20110923_273.jpg

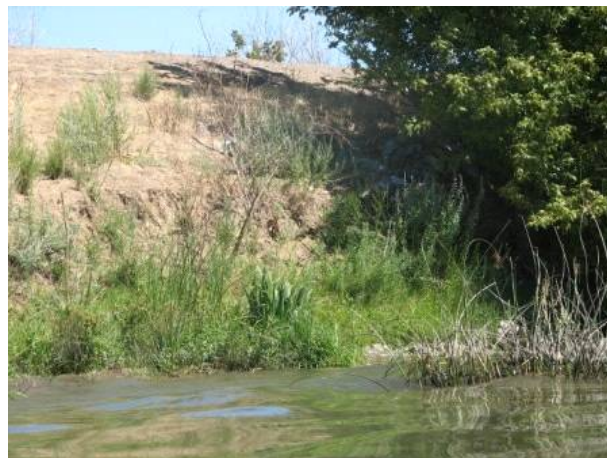
Levee Mile Report Line	11
Start Levee Mile	0.42
End Levee Mile	0.43
Location	Water Side
Category	Supplemental
Item	DWR Erosion Survey
A closer look of the site with minor erosions.	
SJR2011_RD2089U02RM28.35_2.jpg

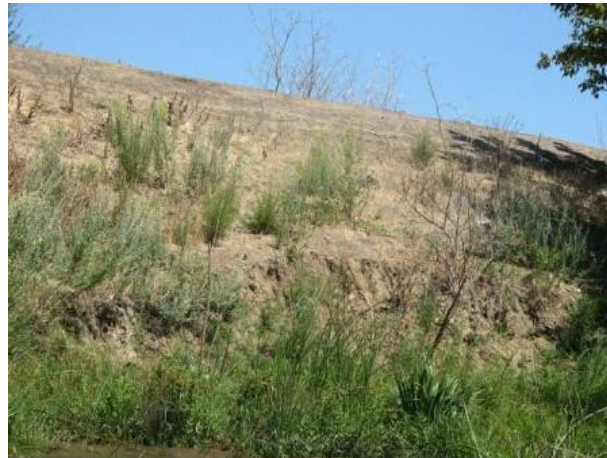
SJR2011_RD2089U02RM28.35_3.jpg

A closer look of the site with minor erosions.

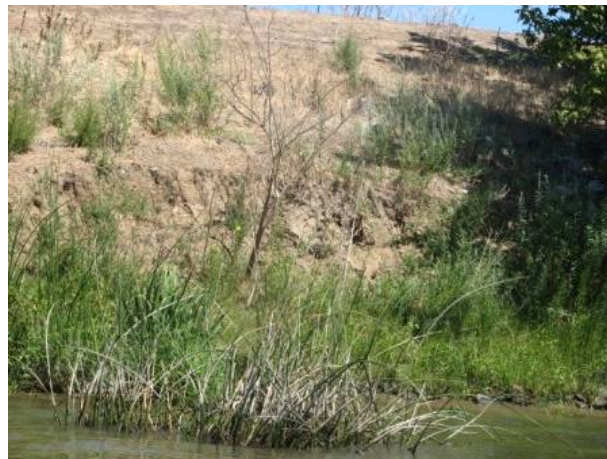
SJR2011_RD2089U02RM28.35_4.jpg

Levee Mile Report Line	11
Start Levee Mile	0.42
End Levee Mile	0.43
Location	Water Side
Category	Supplemental
Item	DWR Erosion Survey

A closer look of the site with minor erosions.

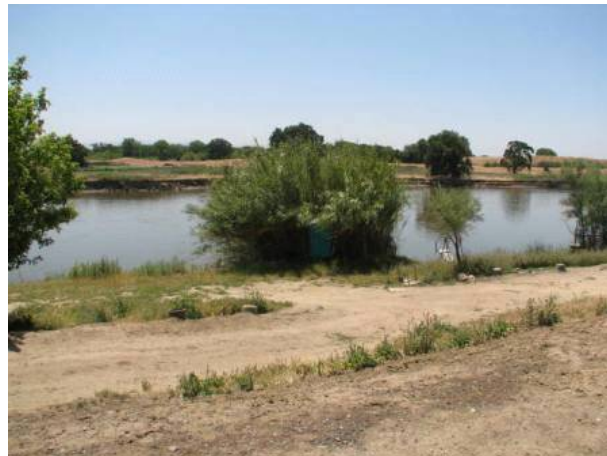
jeto_f_20110923_281.jpg

Levee Mile Report Line	12
Start Levee Mile	0.46
End Levee Mile	0.46
Location	Water Side
Category	Earthen Levee
Item	Encroachments

05/24/2011 Portable toilet is in the shadows in the center of the photo at the water's edge.

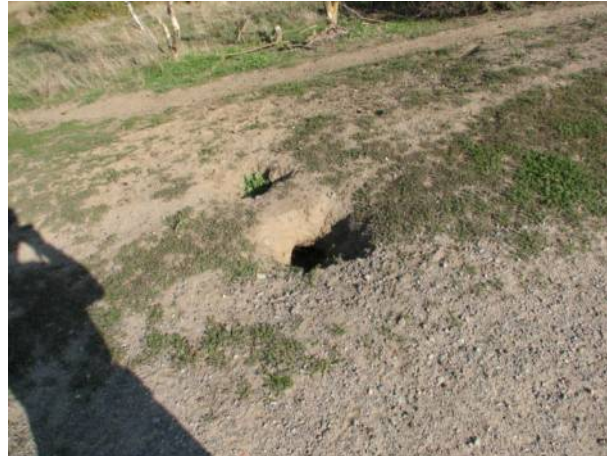
Levee Mile Report Line	13
Start Levee Mile	0.49
End Levee Mile	0.49
Location	Crown
Category	Earthen Levee
Item	Animal Control
11/10/2011 Two large burrows on crown, need to be filled.	
jeto_f_20111118_597.jpg

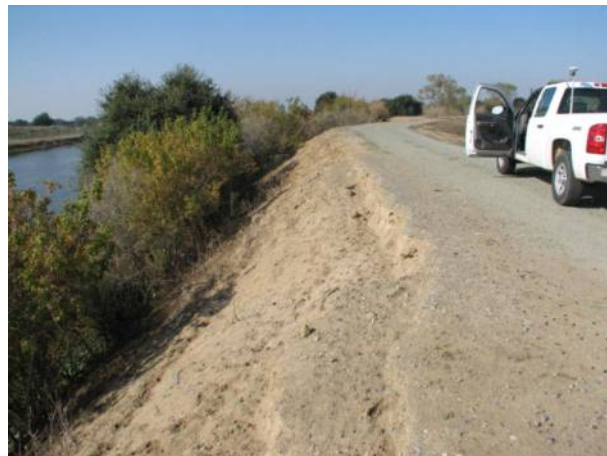
Levee Mile Report Line	15
Start Levee Mile	0.54
End Levee Mile	0.54
Location	Water Side
Category	Earthen Levee
Item	Animal Control
11/10/2011 Approximately 1' scarp has been created by livestock travel.	
jeto_f_20111118_598.jpg

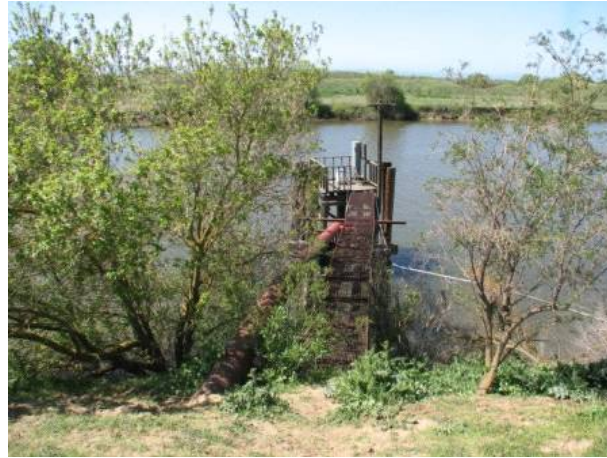
jeto_f_20110923_276.jpg

Irrigation intake pump and pipe at waterside slope.

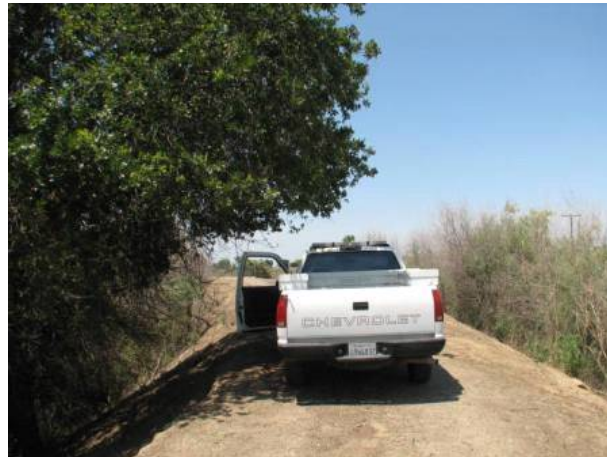
jeto_f_20110923_288.jpg

Levee Mile Report Line	19
Start Levee Mile	0.82
End Levee Mile	0.82
Location	Water Side
Category	Earthen Levee
Item	Trim / Thin Trees

05/24/2011 Trees need to be trimmed up 12' over road.

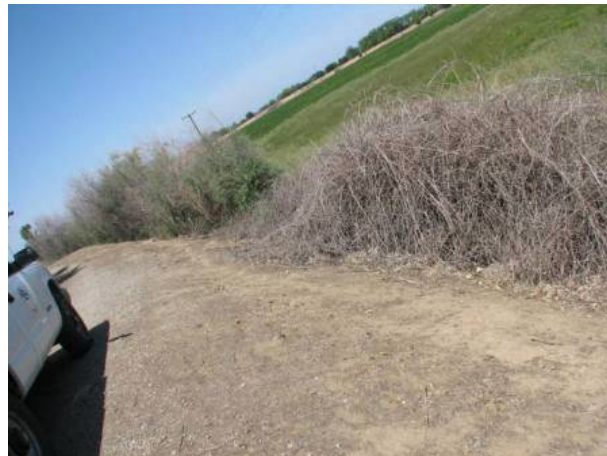
jeto_f_20110923_287.jpg

Levee Mile Report Line	20
Start Levee Mile	0.82
End Levee Mile	0.86
Location	Land Side
Category	Earthen Levee
Item	Vegetation

05/24/2011 Extremely thick dead brush prevents access and visibility.

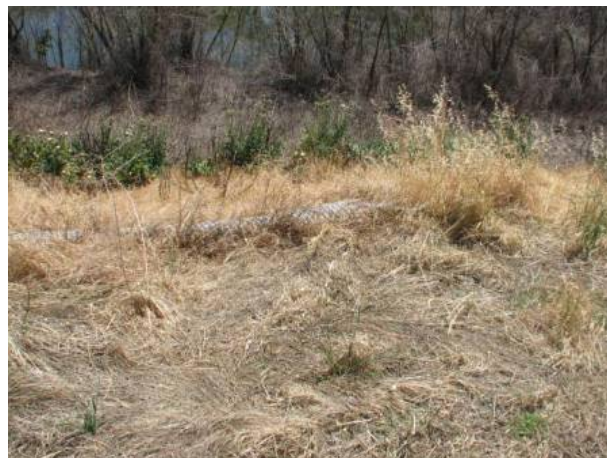
Levee Mile Report Line	26
Start Levee Mile	0.95
End Levee Mile	0.95
Location	Water Side
Category	Earthen Levee
Item	Encroachments
05/24/2011 Old CMP left on waterside levee slope, needs to be removed.	
jeto_f_20110923_291.jpg

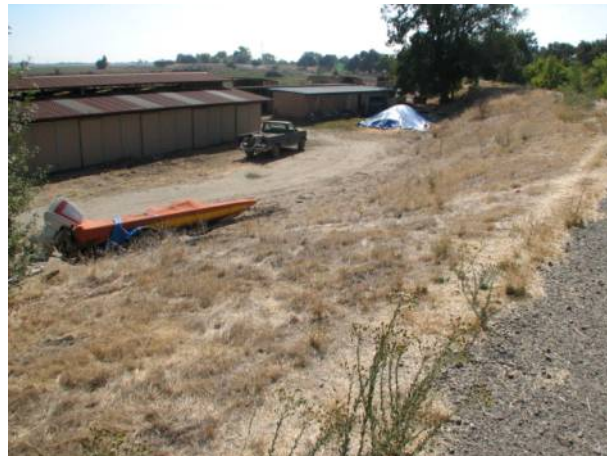
Levee Mile Report Line	33
Start Levee Mile	1.28
End Levee Mile	1.33
Location	Land Side
Category	Earthen Levee
Item	Encroachments
Fall 2009 photo: boat and equipment stored within 10-ft of levee slope are an encroachment.	
jeto_f_20110923_277.jpg

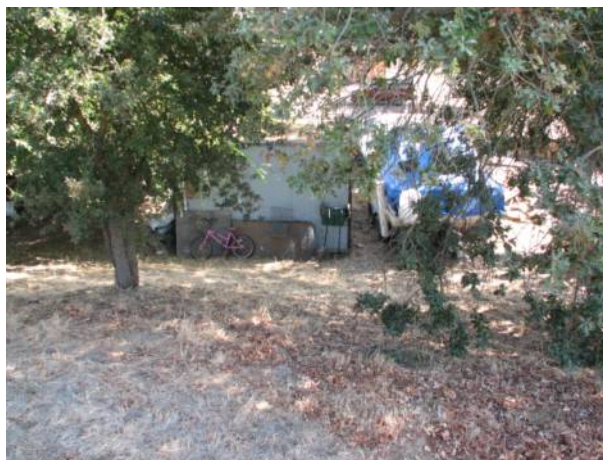
jeto_f_20110923_278.jpg

Fall 2009 photo: Buildings and patio decks are built within 10-ft of the levee slope.

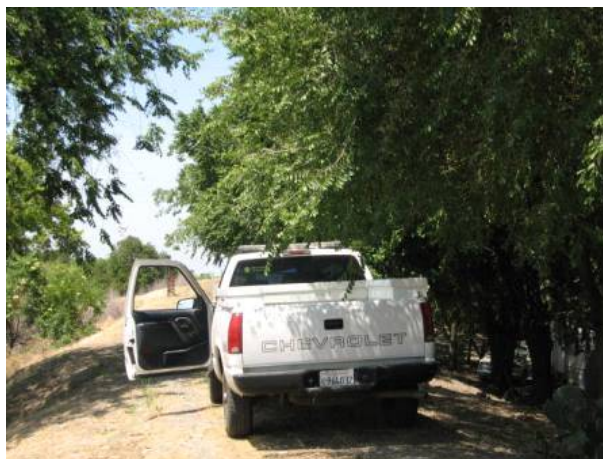
jeto_f_20110923_292.jpg

Levee Mile Report Line	34
Start Levee Mile	1.30
End Levee Mile	1.33
Location	Water Side
Category	Earthen Levee
Item	Trim / Thin Trees

05/24/2011 Low hanging trees need to be trimmed up 12' over road.
